HO-996

8831 Stephens Road
Laurel vicinity
Private

Historic Properties Form

Inventory No. HO-996

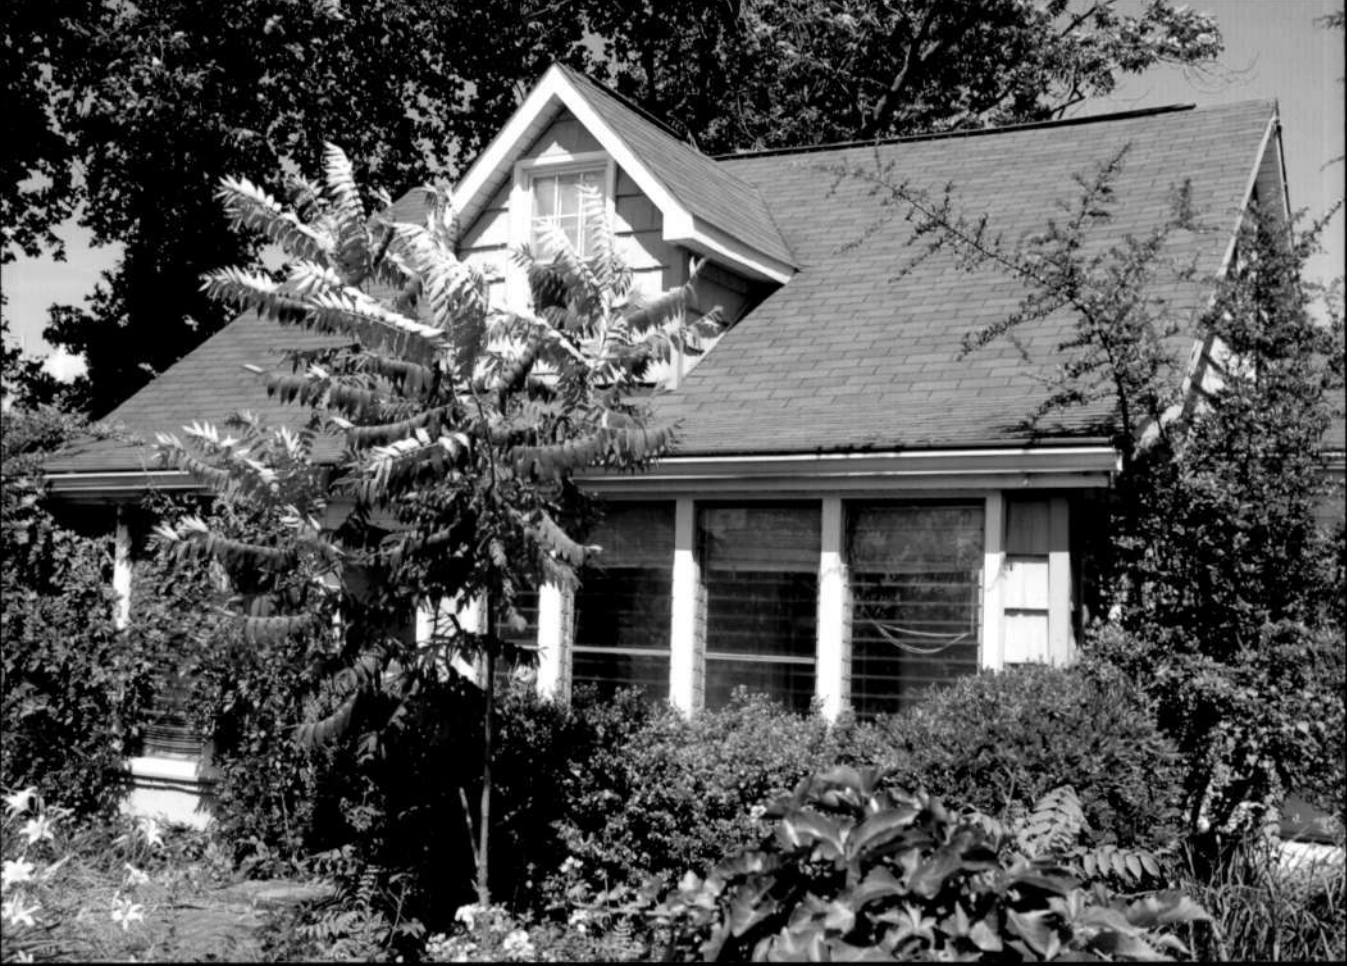
1/4

HO-0996_2009-07-07_01
West & southwest elevations

West & Southwest Elevation.

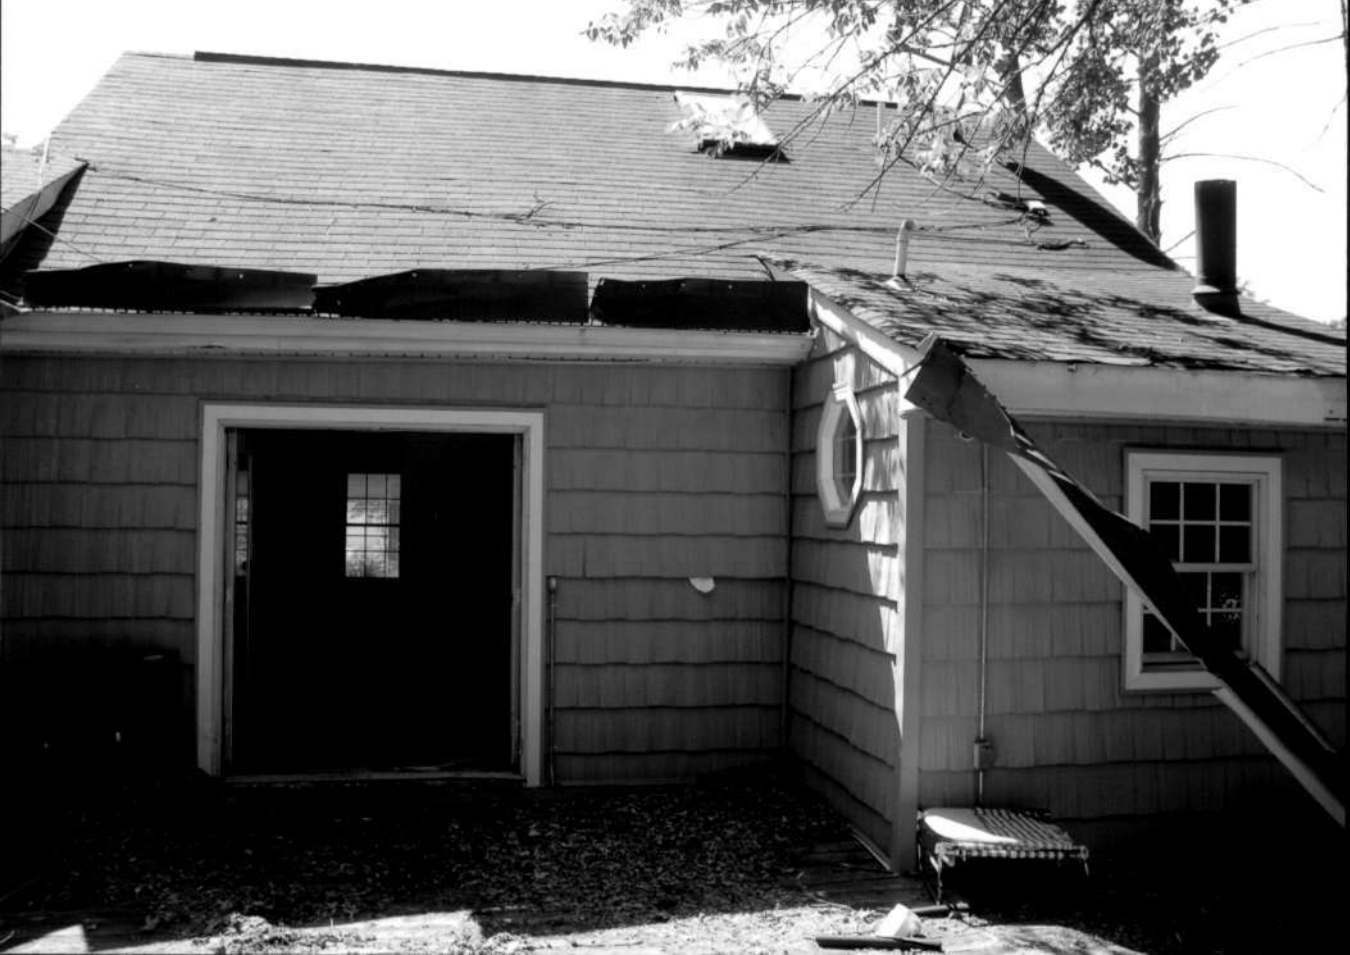
2/4

HO-0996_2009-07-07_02
East elevation

East Elevation

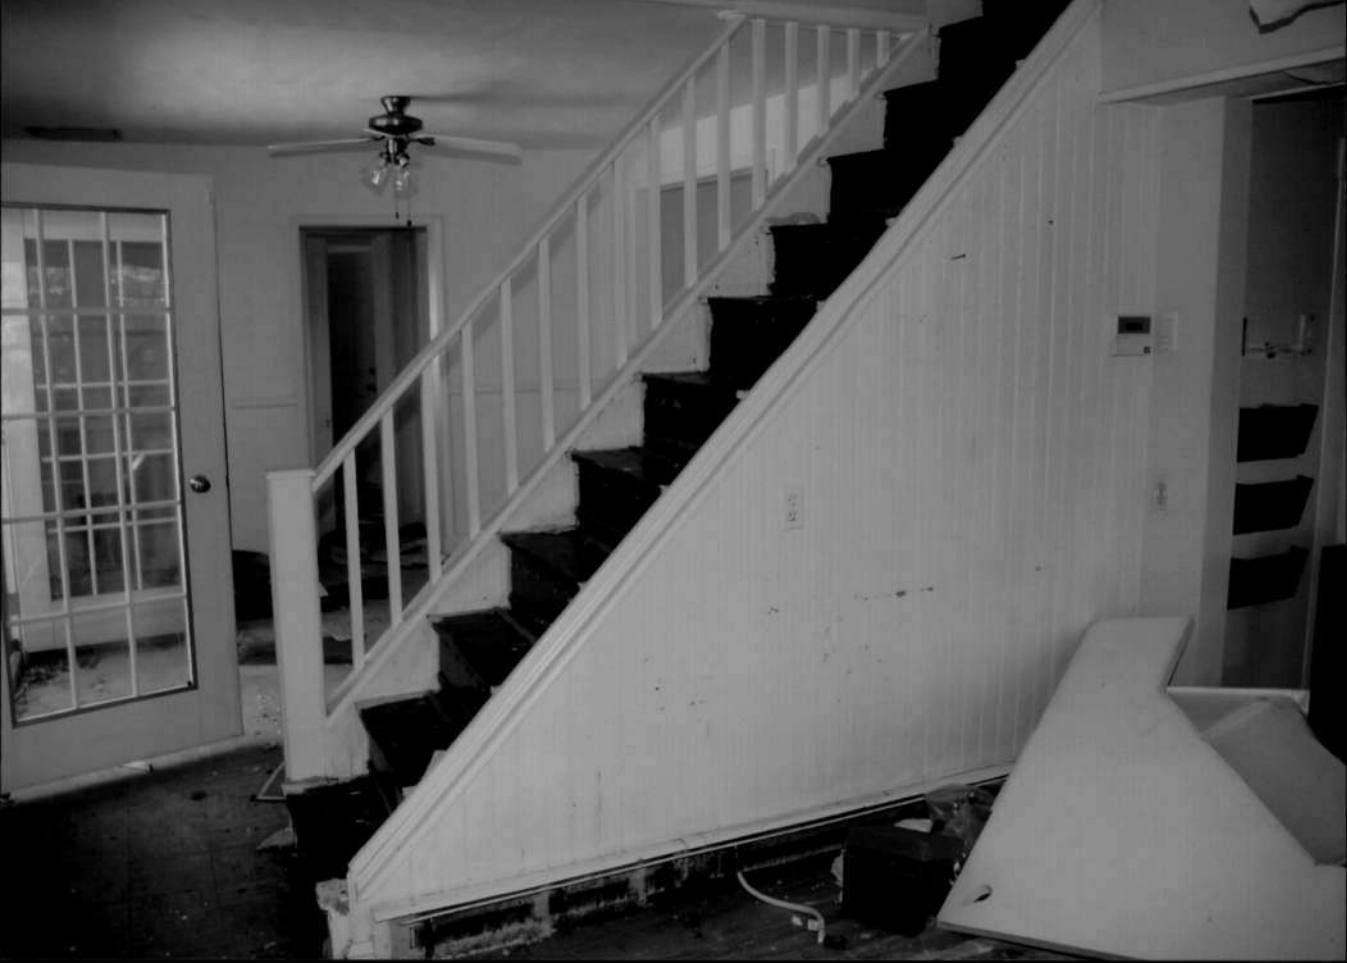
3/4

rafters are dimensional 2 by 6s, and there is circular-sawn lath and plaster. The modern addition on the south side is a separate apartment.

HO-0996_2009-07-07_03
Interior, stairway, view south

Interior, Stairways, view south
